Manhole Inspection Summary

Manhole # S43C__033MH

Inspection ☐ Is Incomplete Rating: **3) Fair**

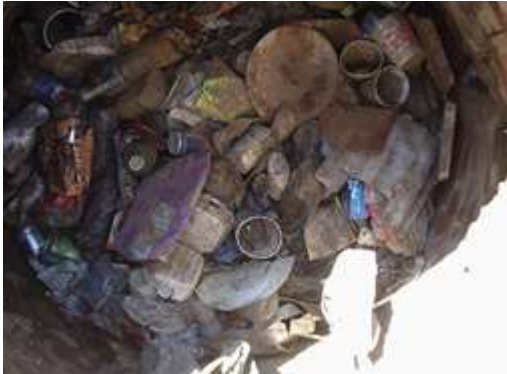
Top View

trash

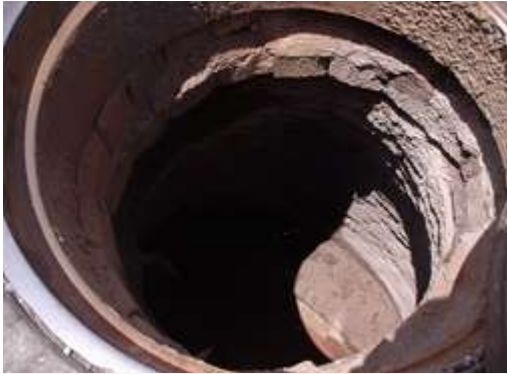
Defect 1

Frame Offset: **3** (in.) Condition: ☒ Sound ☐ Cracked ☐ Leaks

offset frame

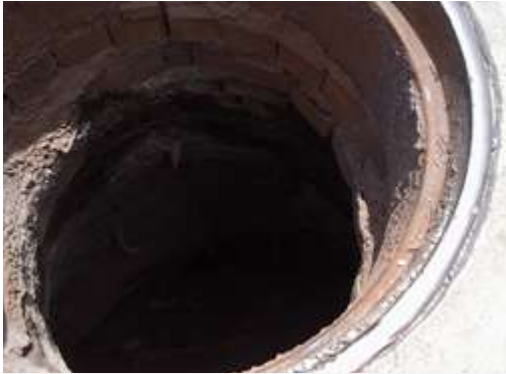
Defect 2

Steps Count: **3** Missing: **3** ☐ Corroded

broken steps

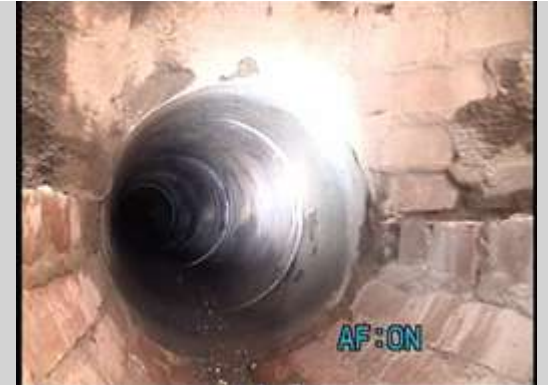
12 O'Clock Outflow

15 in. Circular Gravity Sewer
Pipe Out @ 12 O'Clock

Infiltration: **None** Pipe Seal Cond: **Sound**

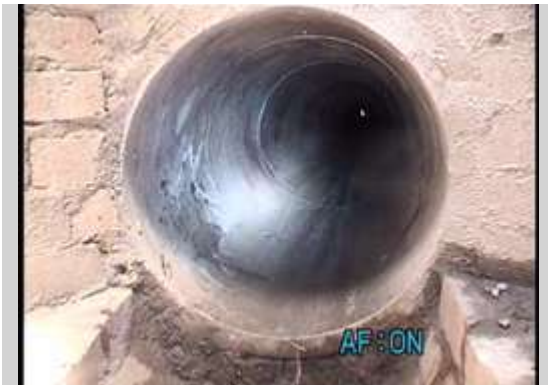
6 O'Clock Inflow

15 in. Circular Gravity Sewer
Pipe In @ 6 O'Clock

Infiltration: **None** Pipe Seal Cond: **Sound**
